Case 280 : Narrative

Case Vehicle (A): 1999 Mazda
Type: MX5 Miata, 2-door convertible
Driver: 49-year-old male
CDC: 12-FCEN-3

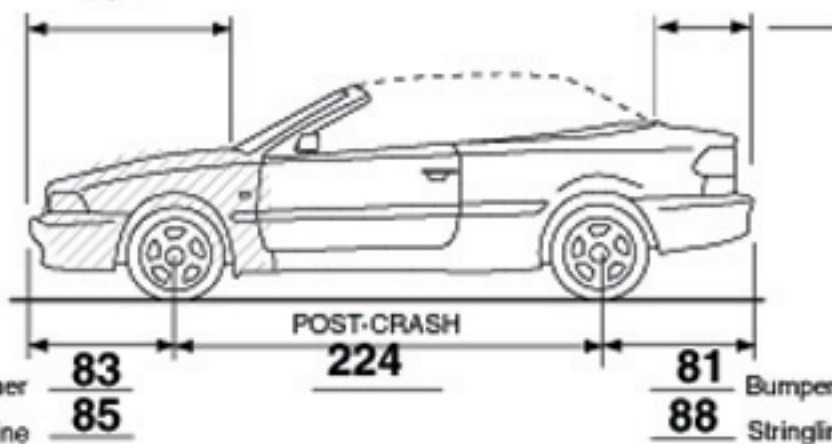
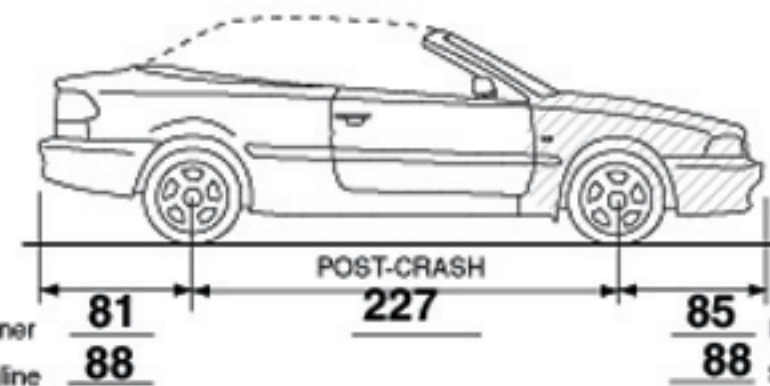
23-cm direct damage
55-cm maximum crush

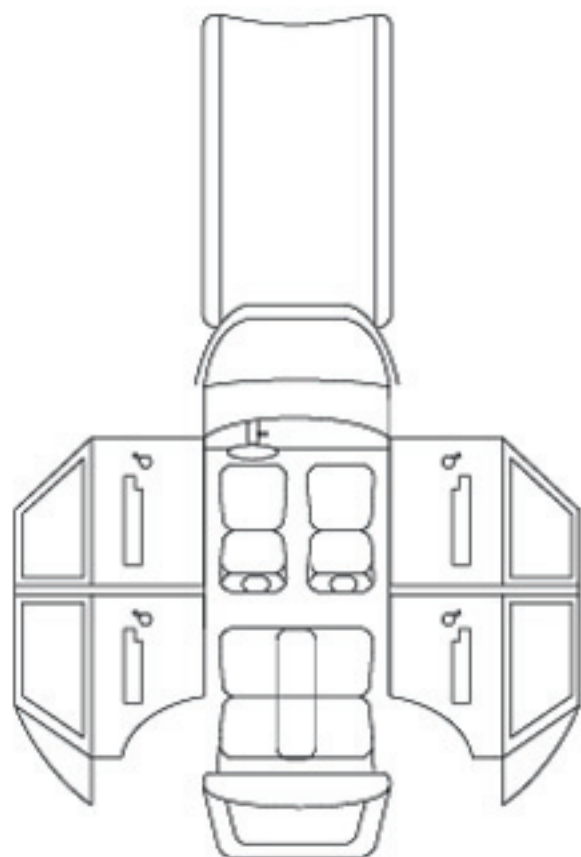
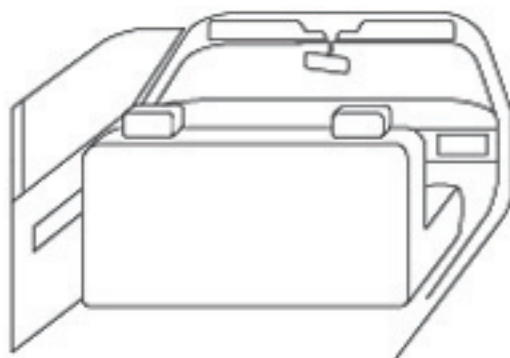
Diver belt use evidence:
 belt is locked into extended position
 light scratches on latch plastic
 scratches on D-ring
 top cover popped off
 4-cm plastic transfer on shoulder-belt
 webbing from D-ring

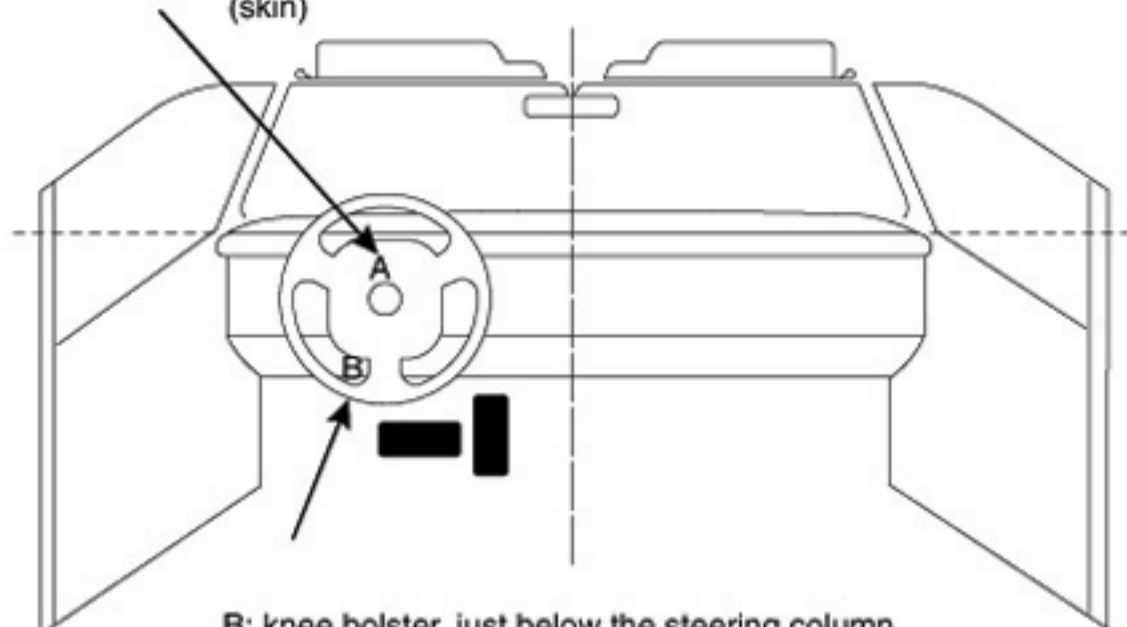
A: steering-wheel airbag
 (skin)

B: knee bolster, just below the steering column
 (2 - 2x2-cm scuff marks)
